RCRA Case Development Inspection

BURKE-PARSONS-BOWLBY CORPORATION

Date of Inspection: March 24, 2005

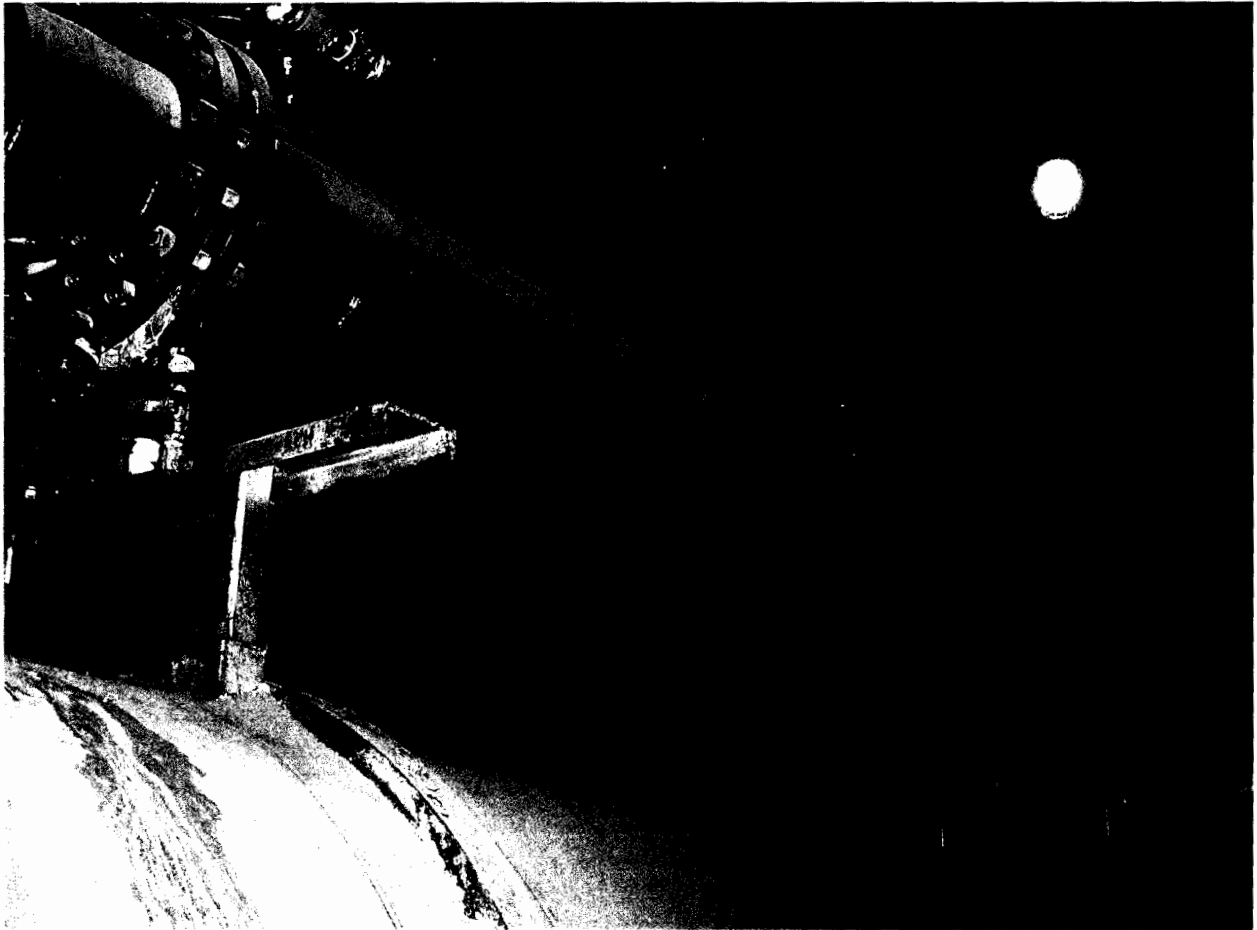
Photograph No. 3

Condensor associated with Treatment Cylinder No. 1. After the water vapor has been directed through the surge tank, it is piped through a condensor, which is basically a steel pipe jacketed with cold water. The condensor cools the water vapor, changing it back into a liquid form. The condensed liquid is referred to as condensate and consists of an oil/water mixture.

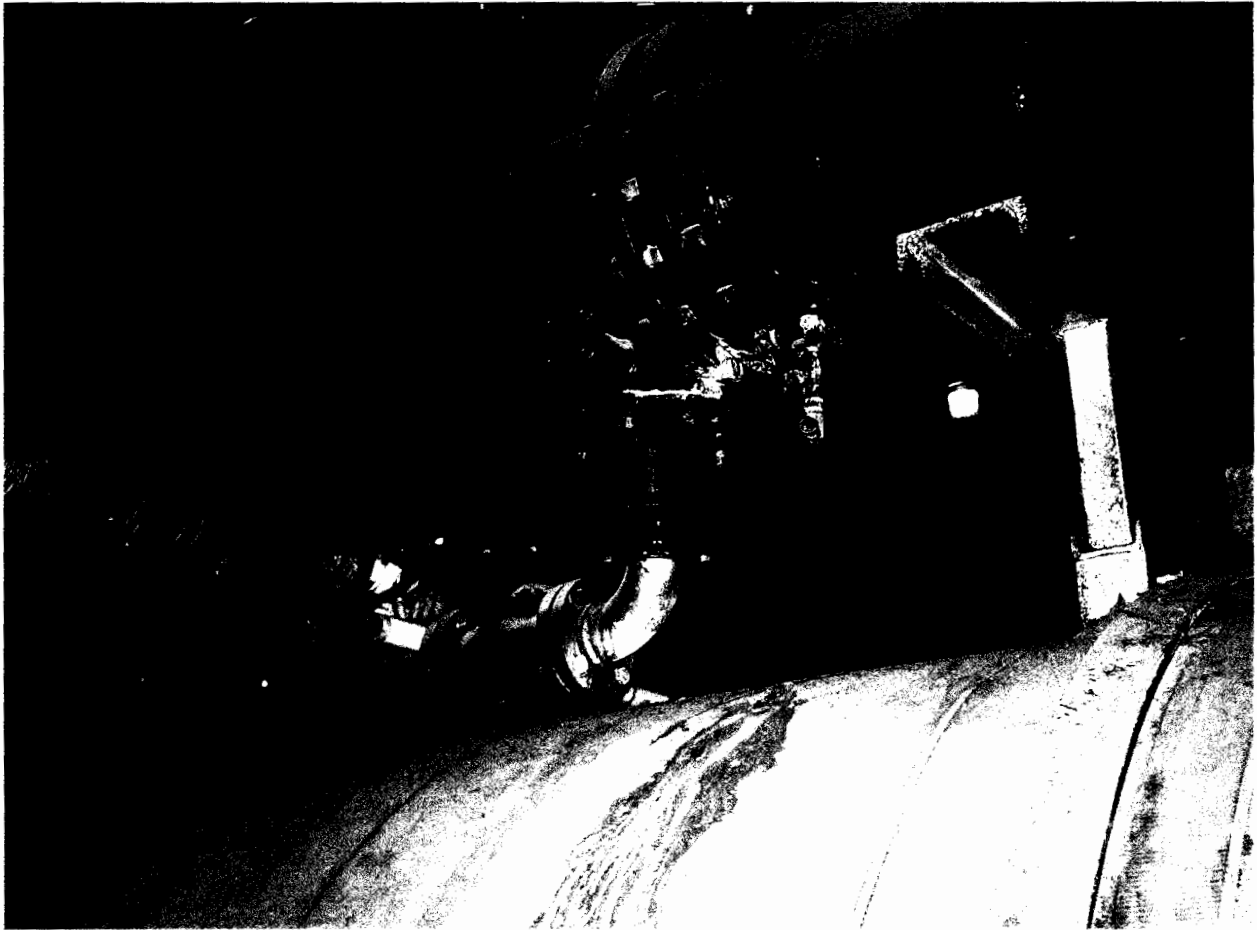
Photograph No. 5

End of condensor associated with Treatment Cylinder No. 1. The condensate exits the condensor and is directed through hard piping to the work tank.

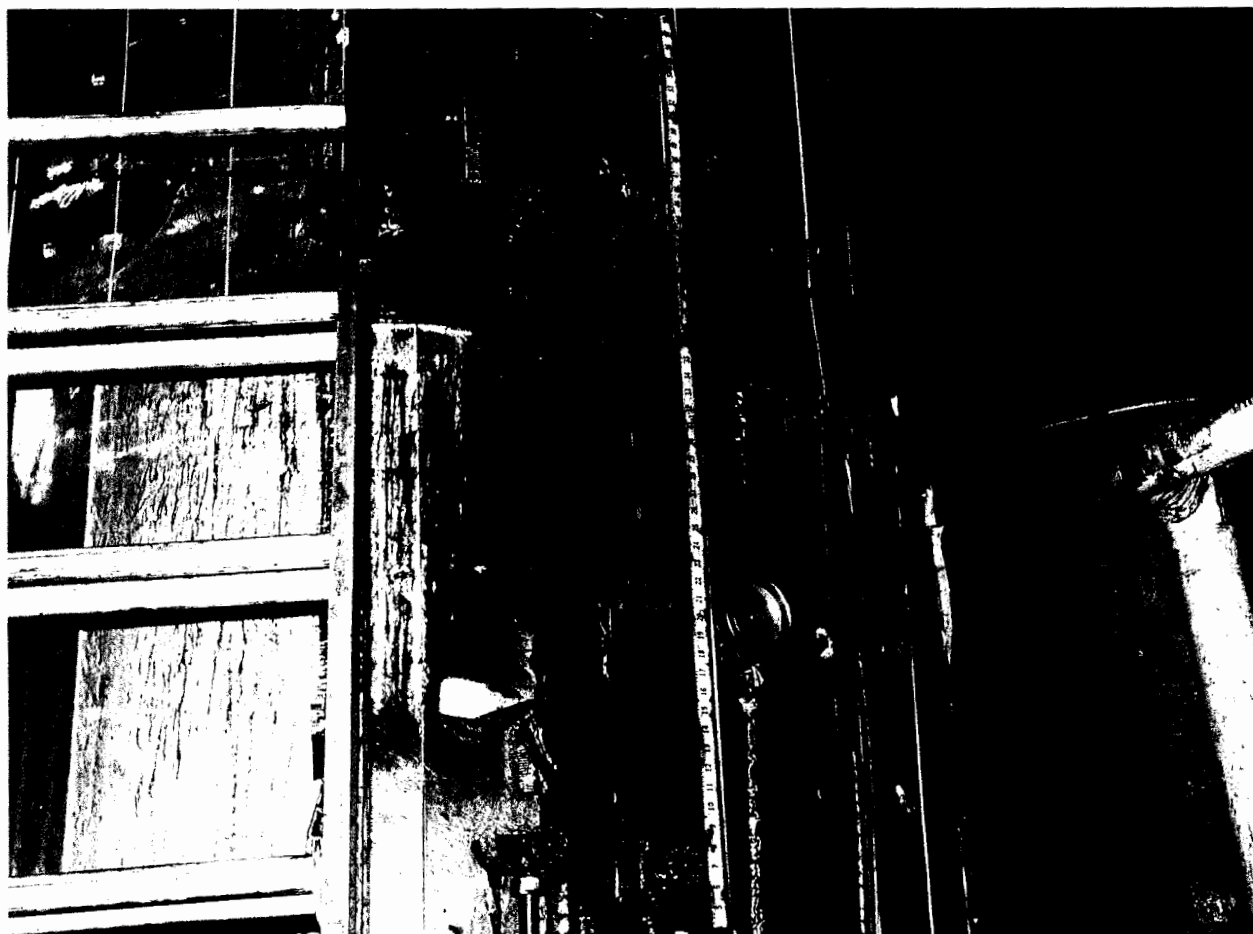
Photograph No. 8

Evaporator Unit. Same description as Photograph No. 7. This photograph shows creosote that has spilled on the outside of the tank. The tank is also equipped with gauges to tell the volume of the tank, however, Mr. Gentry was unsure of their accuracy.

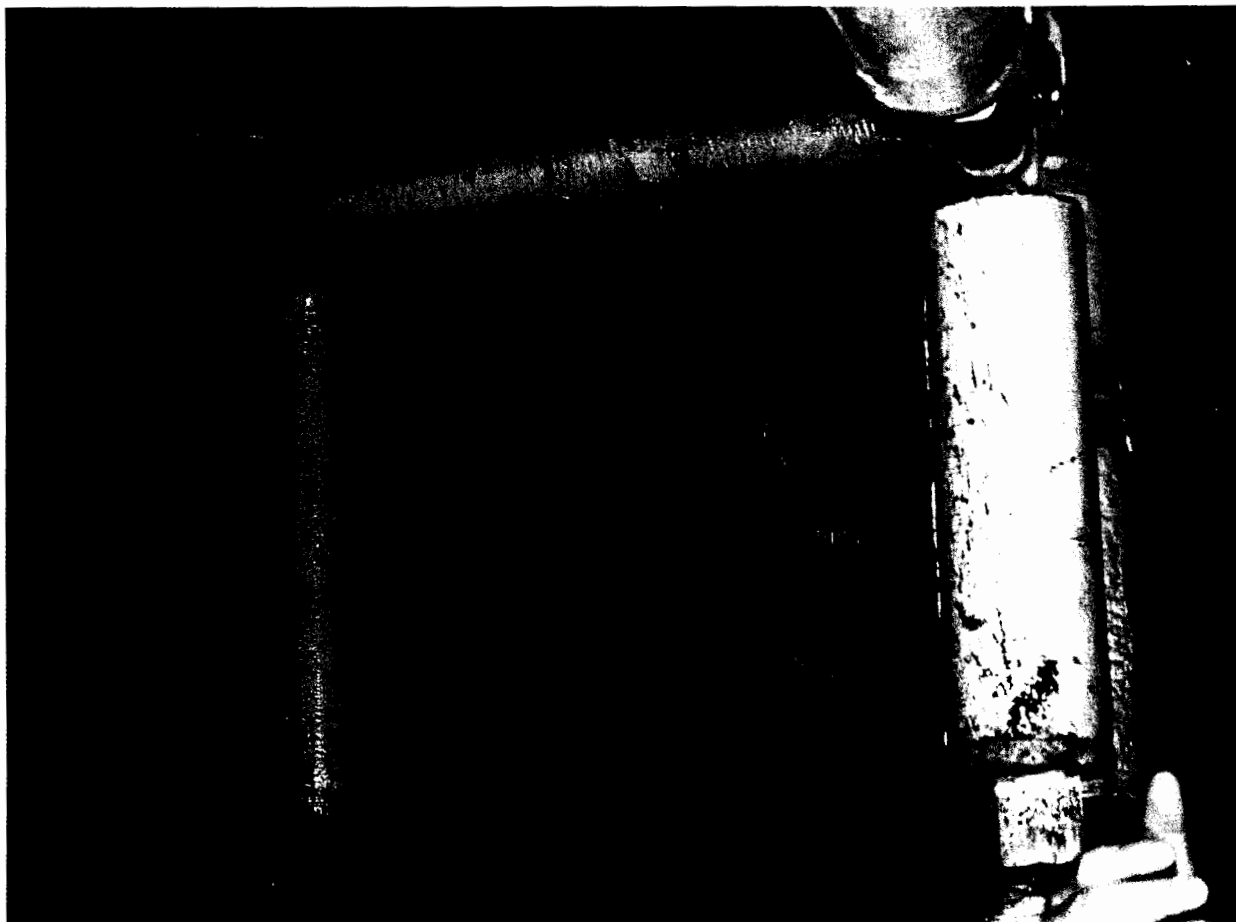
Photograph No. 9

Piping that provides steam for the coils inside of the evaporator unit. The coils heat up the condensate resulting in the water in the condensate being boiled off into the atmosphere.

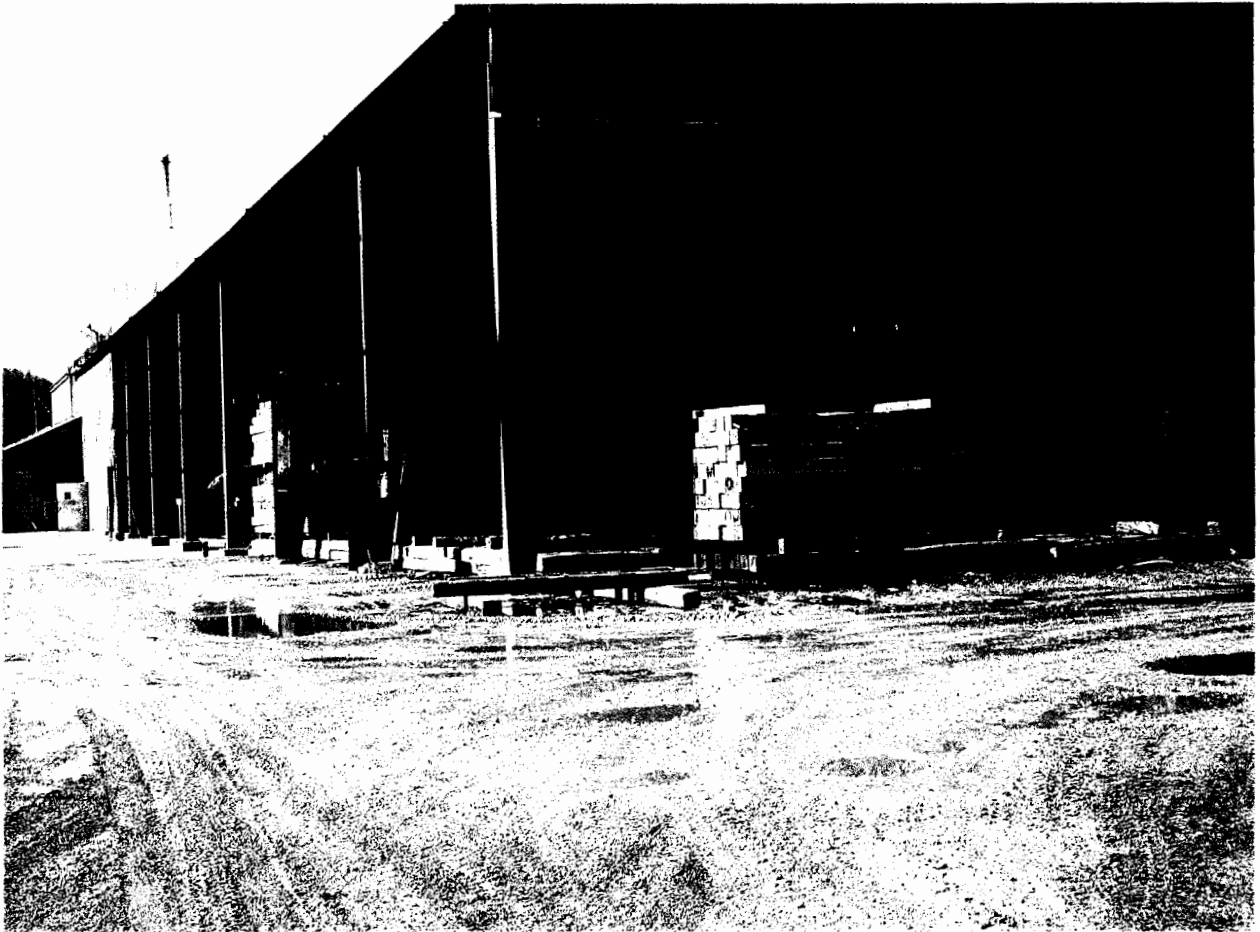
Photograph No. 12

Facility's drip pad. The entire drip pad is covered with a roof and closed on two sides.

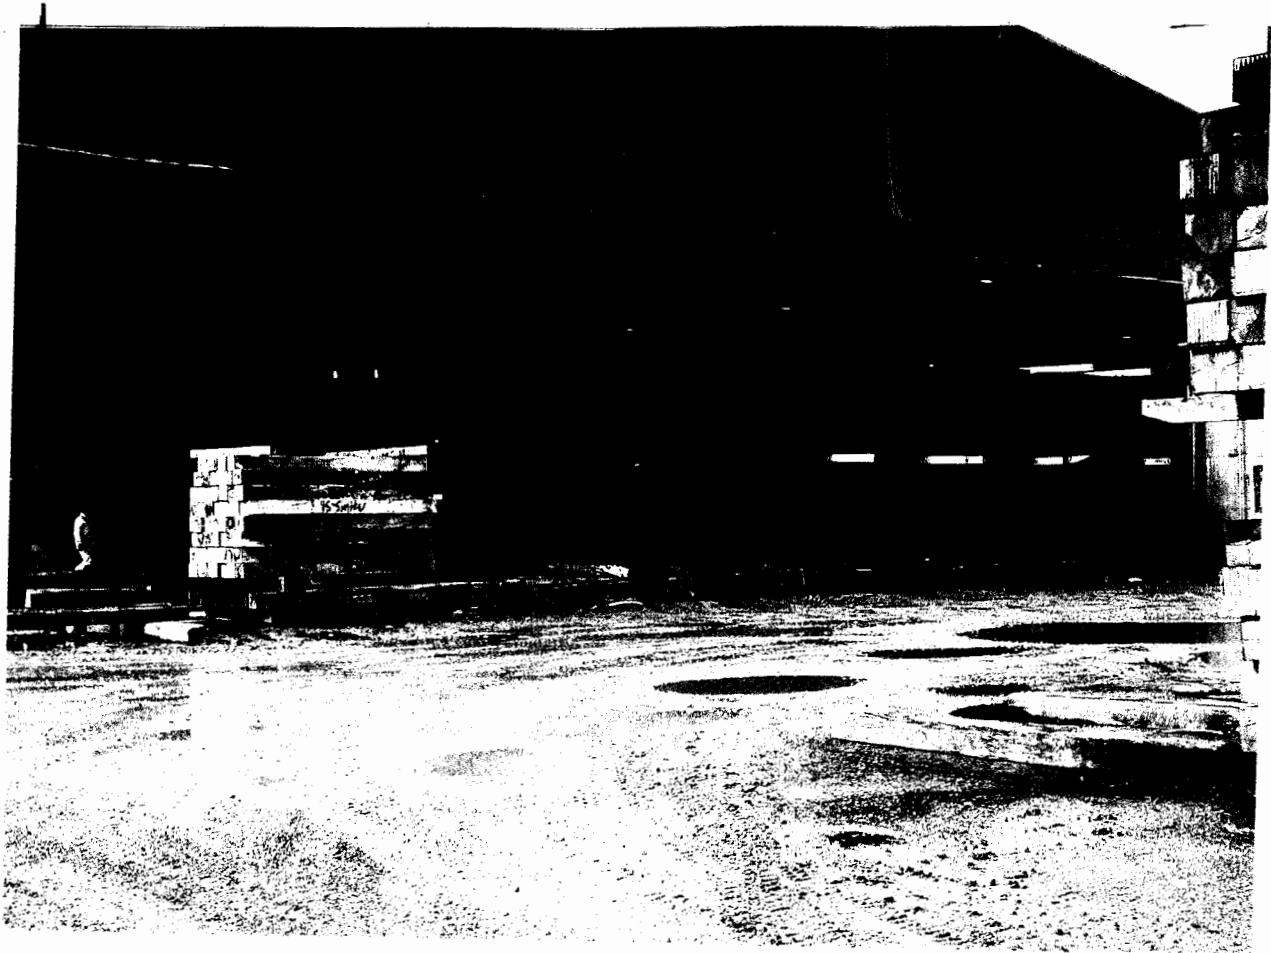
Photograph No. 13

Same as description as Photograph No. 12. Different angle of drip pad. Charges of treated wood are stacked at this end of the drip pad for transfer to the storage yard.

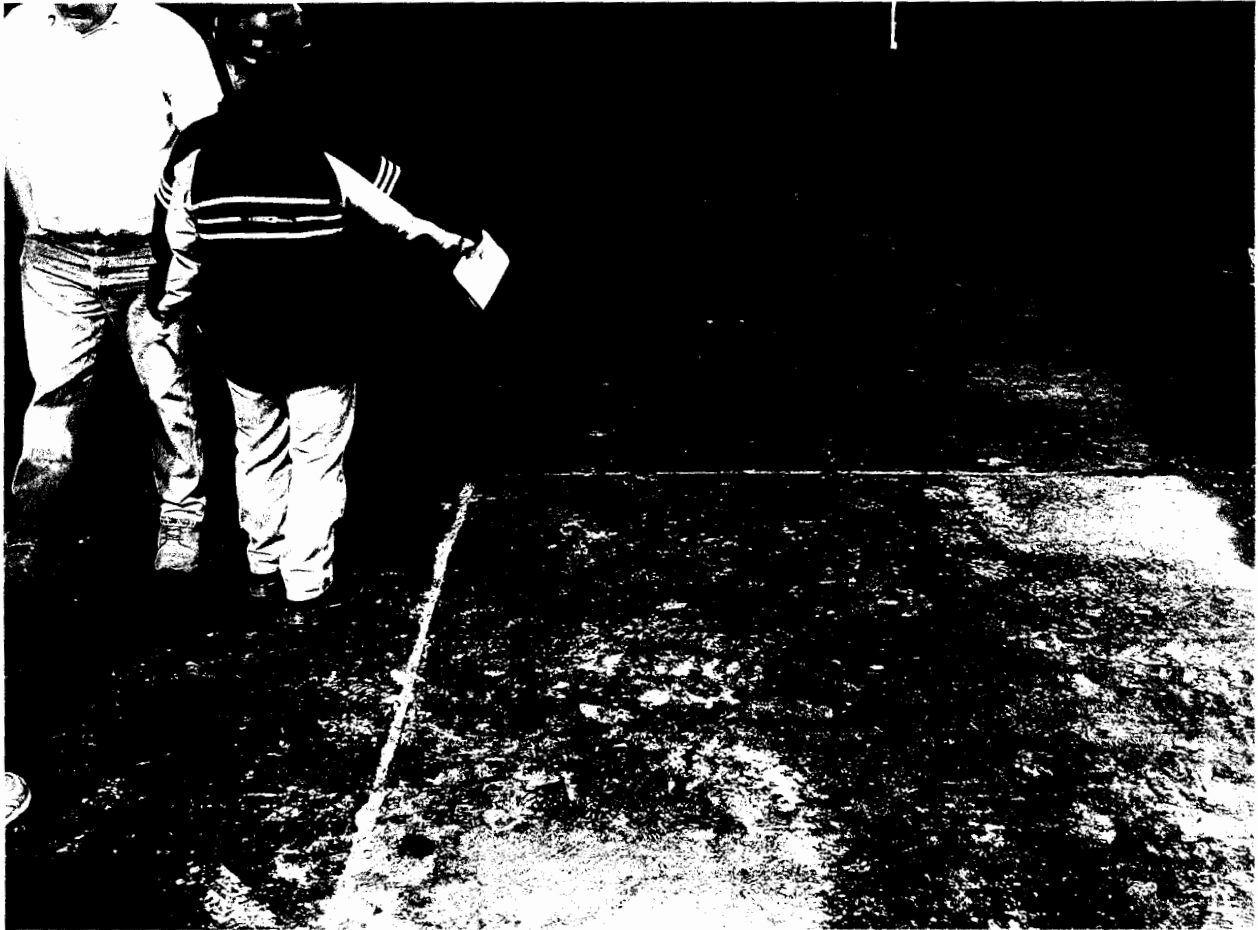
Photograph No. 15

Picture taken from North-East corner of drip pad facing West. This photograph shows the North end of the drip pad. The joint that runs the length of the photograph is the divider between the actual drip pad and the apron. The drip pad is to the left of the joint and slopes toward the treatment cylinders, while the apron is to the right and slopes toward the storage yard. There is no berm for this end of the drip pad. The inspectors noted that the apron did have a build-up of creosote on it.

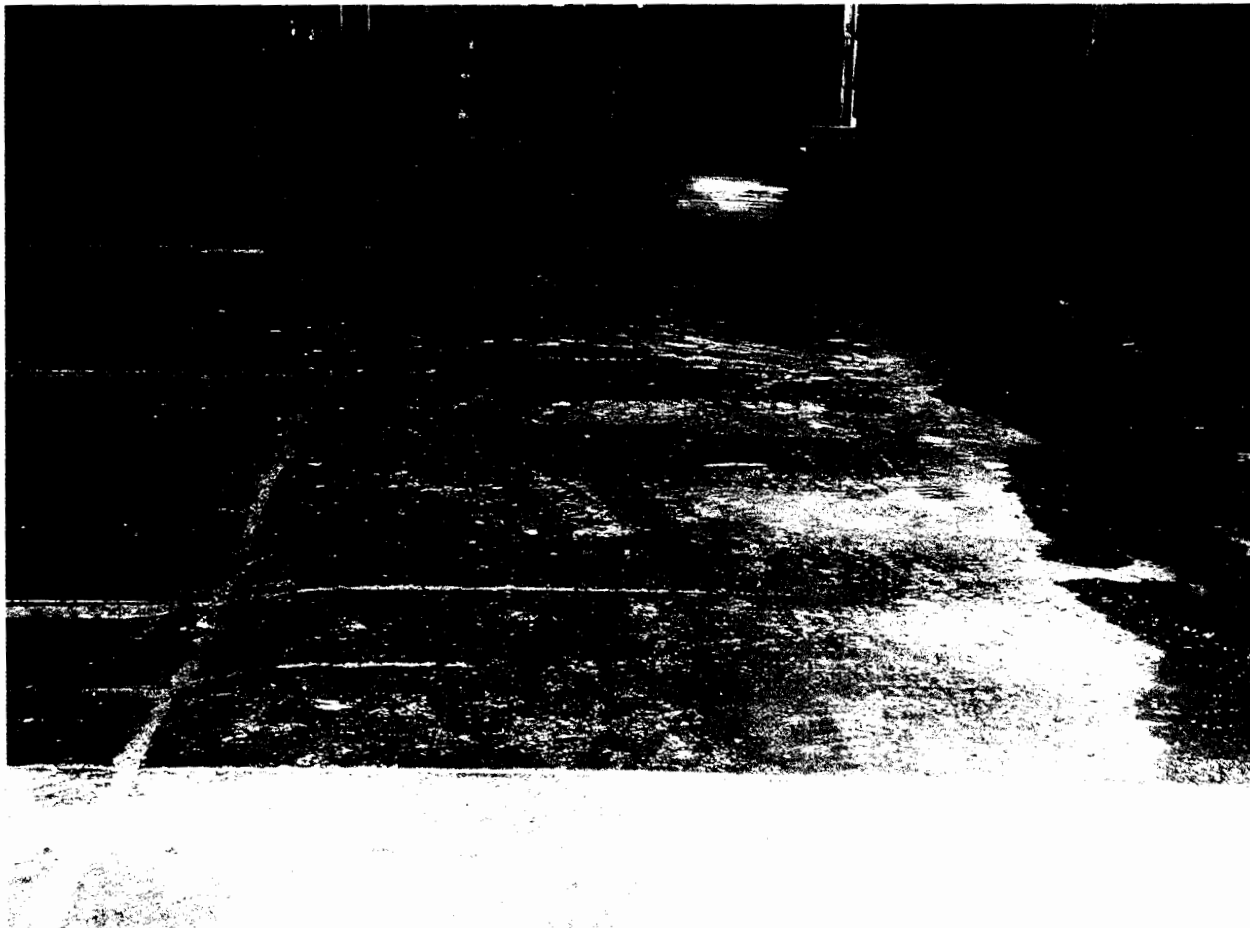
Photograph No. 16

Same description as Photograph No. 15.

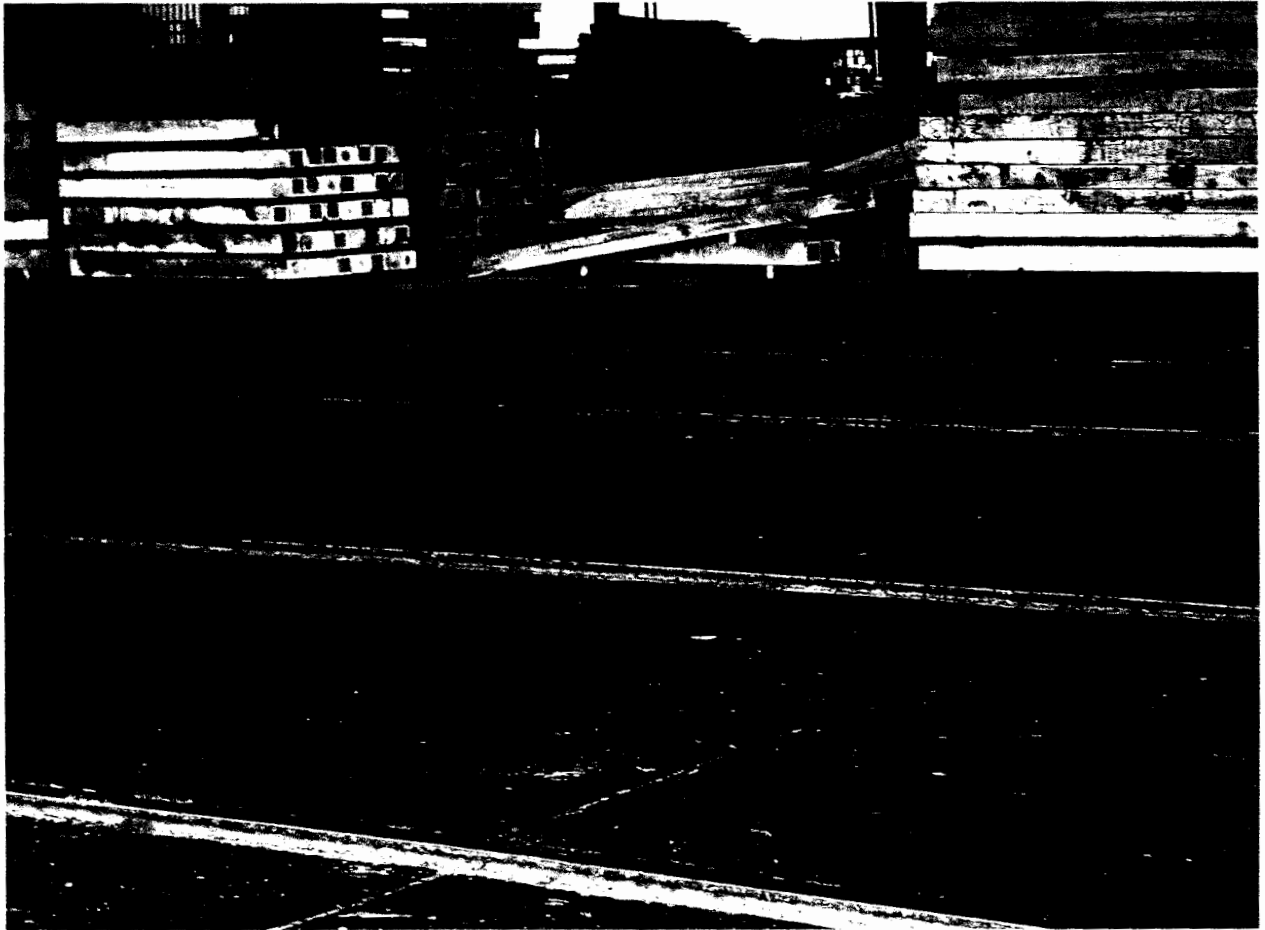
Photograph No. 17

Photograph of drip pad taken from North-East corner facing South-West.

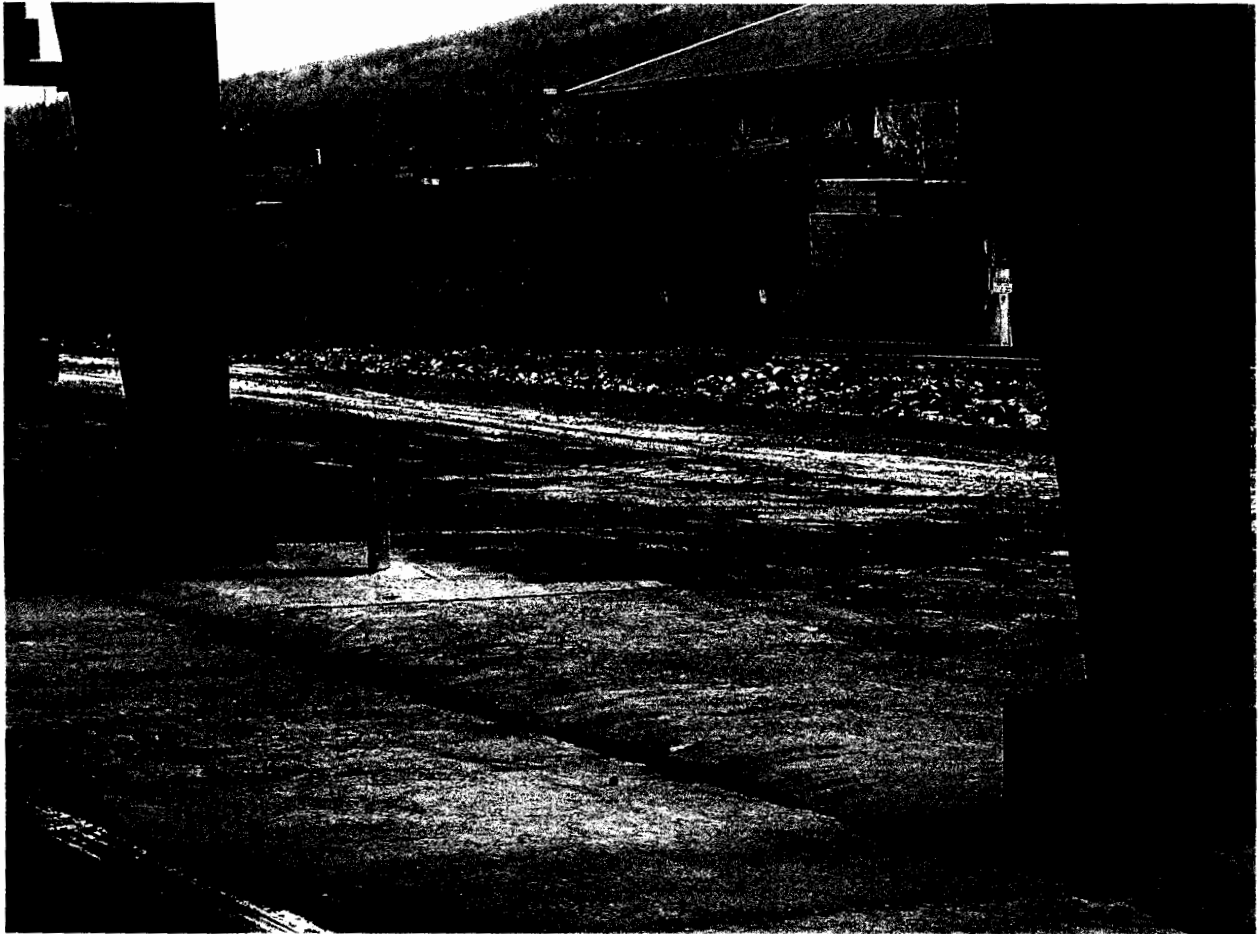
Photograph No. 18

Photograph of Facility drip pad, apron and berm taken from South-East Corner facing North-East. The drip pad ends and the apron/berm begins at the joint closest to the pillars that runs the length of the picture. The berm consists of a slight "hump" where the apron begins to keep preservative from running off of the pad, in addition to keeping water from running onto the pad.

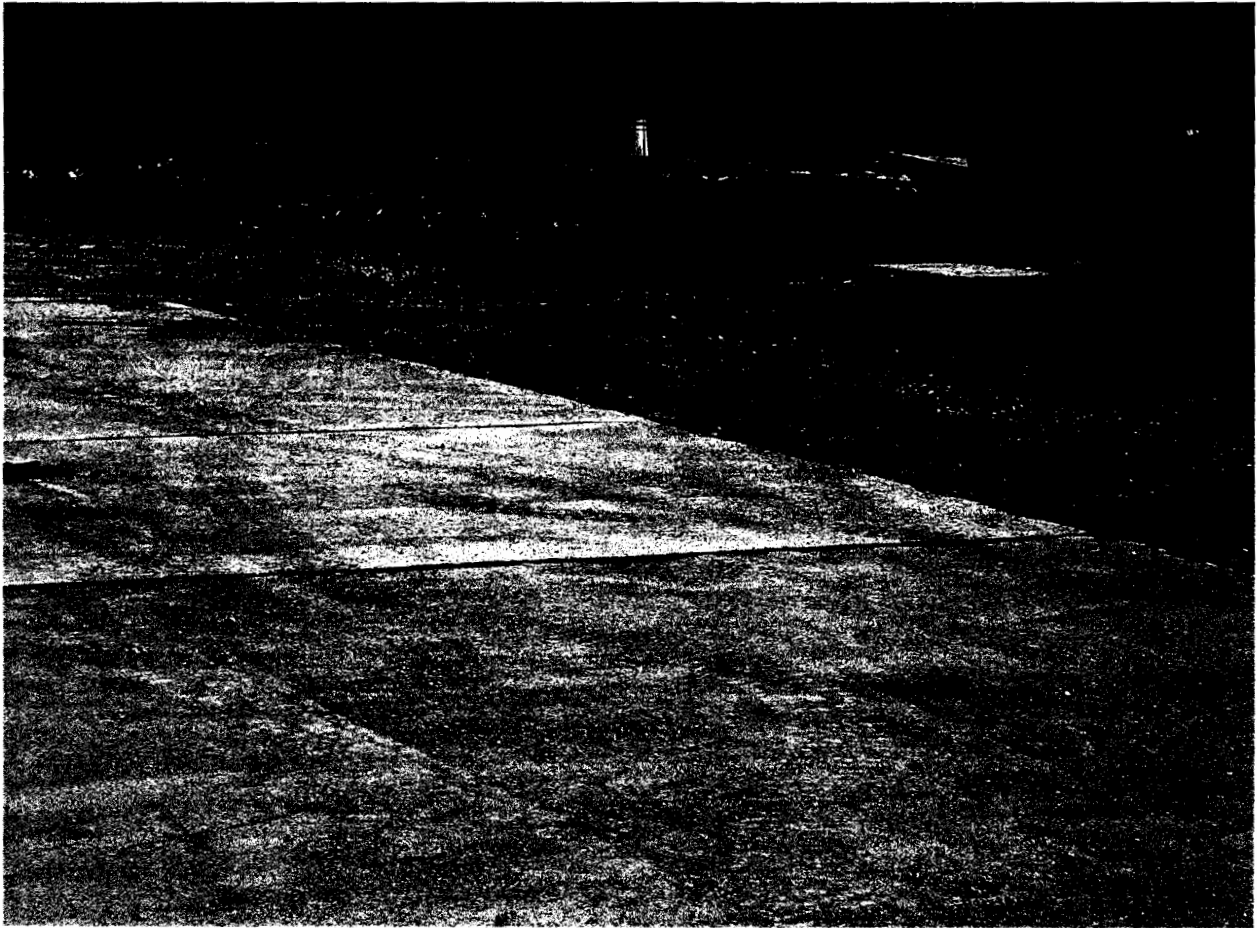
Photograph No. 21

Photograph of apron on East side of drip pad, next to railroad tracks. The apron extends out past the roof that covers the drip pad.

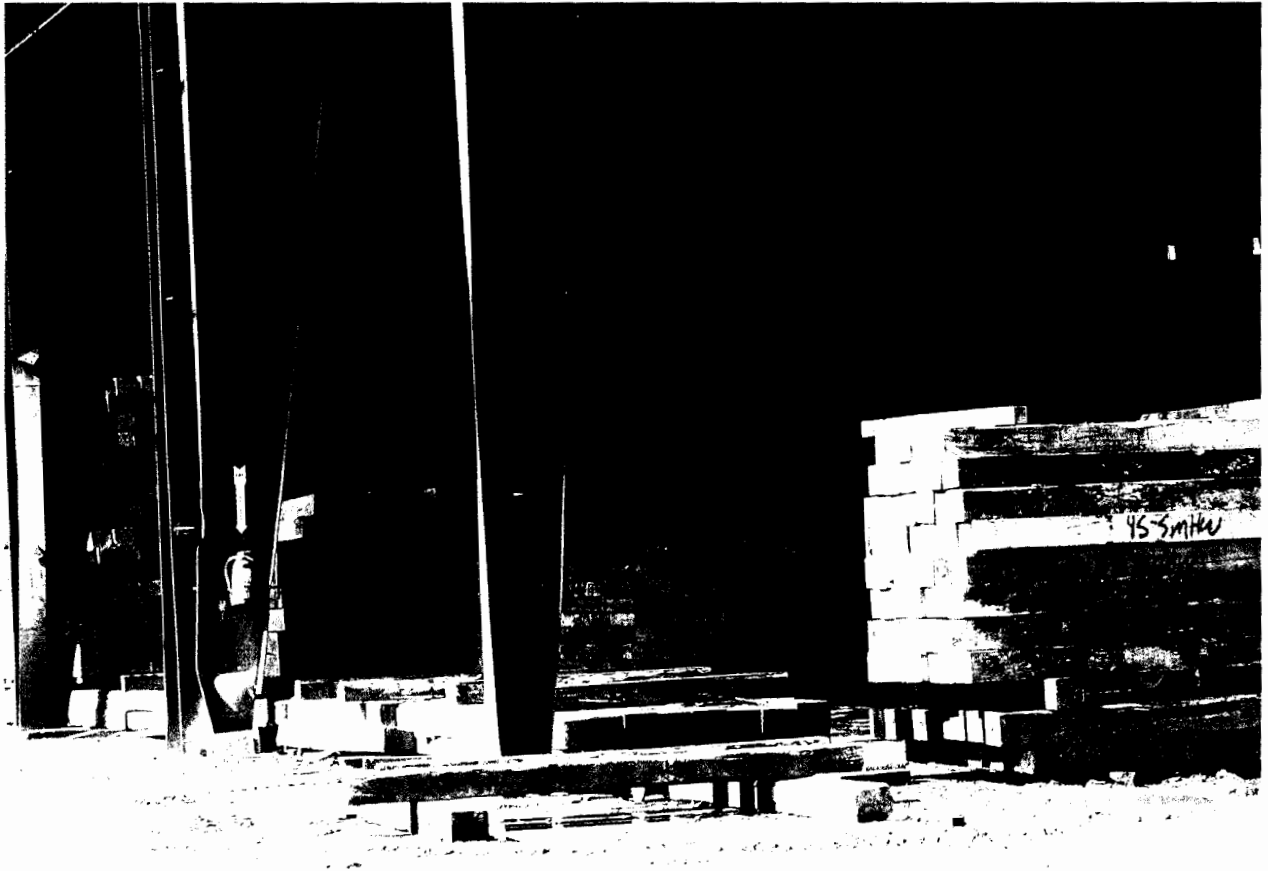
Photograph No. 22

Drip pad. Photograph taken from outside North-East corner of drip pad.

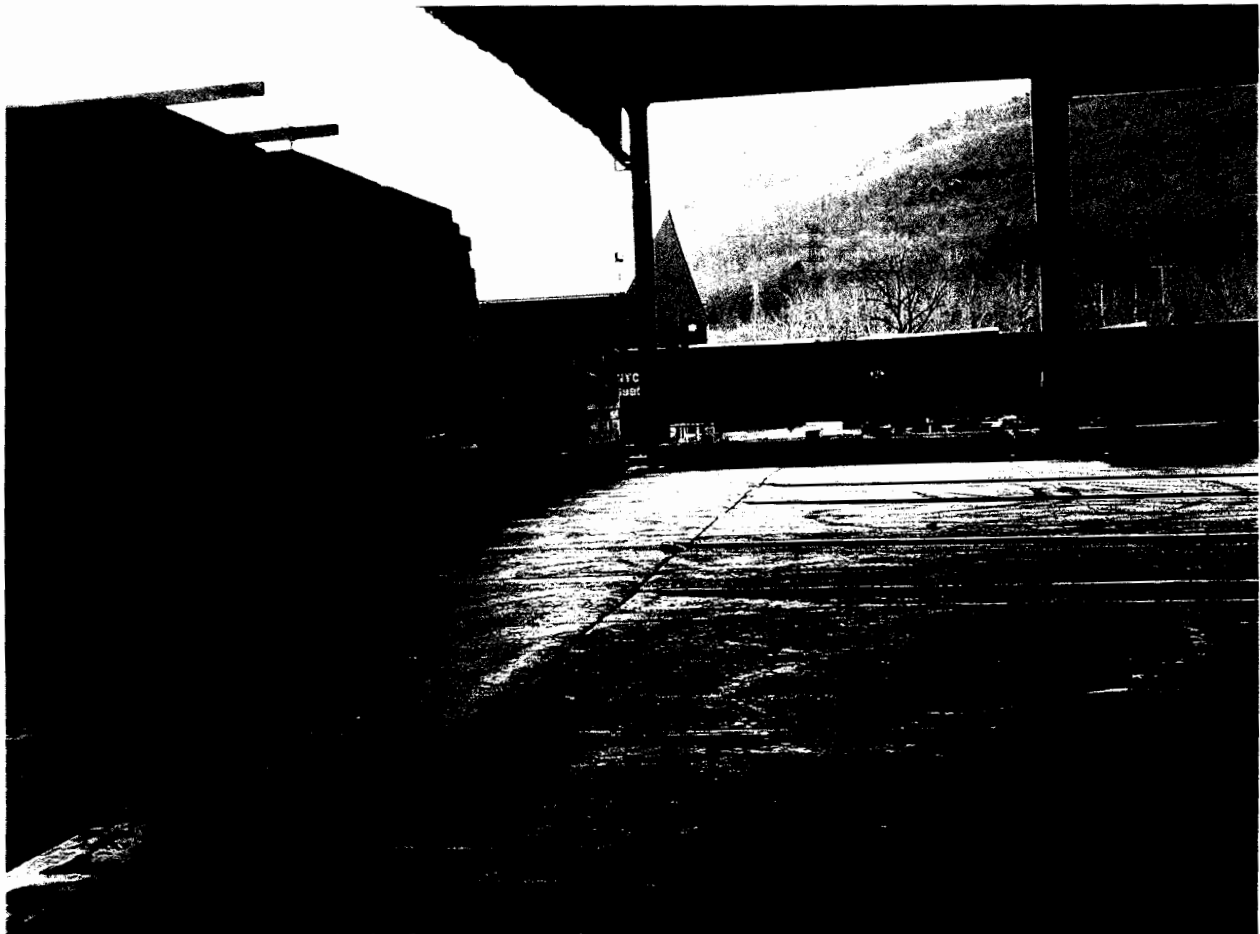
Photograph No. 24

Photograph of North end of drip pad taken from North-West corner of drip pad facing North-East. Drip pad ends and apron begins at the joint that runs the length of photograph. Mr. Gentry stated there is no berm or curb for this end of the drip pad. The drip pad slopes toward the treatment cylinders, which are to the right, and the apron slopes away from the treatment cylinders toward the storage yard, which is to the left.
